Debris/Ice/TPS Assessment And Photographic Analysis For Shuttle Mission STS-39

Gregory N. Katnik
NASA/Kennedy Space Center

DEBRIS/ICE/TPS ASSESSMENT
AND
PHOTOGRAPHIC ANALYSIS
OF
SHUTTLE MISSION STS-39

April 28, 1991

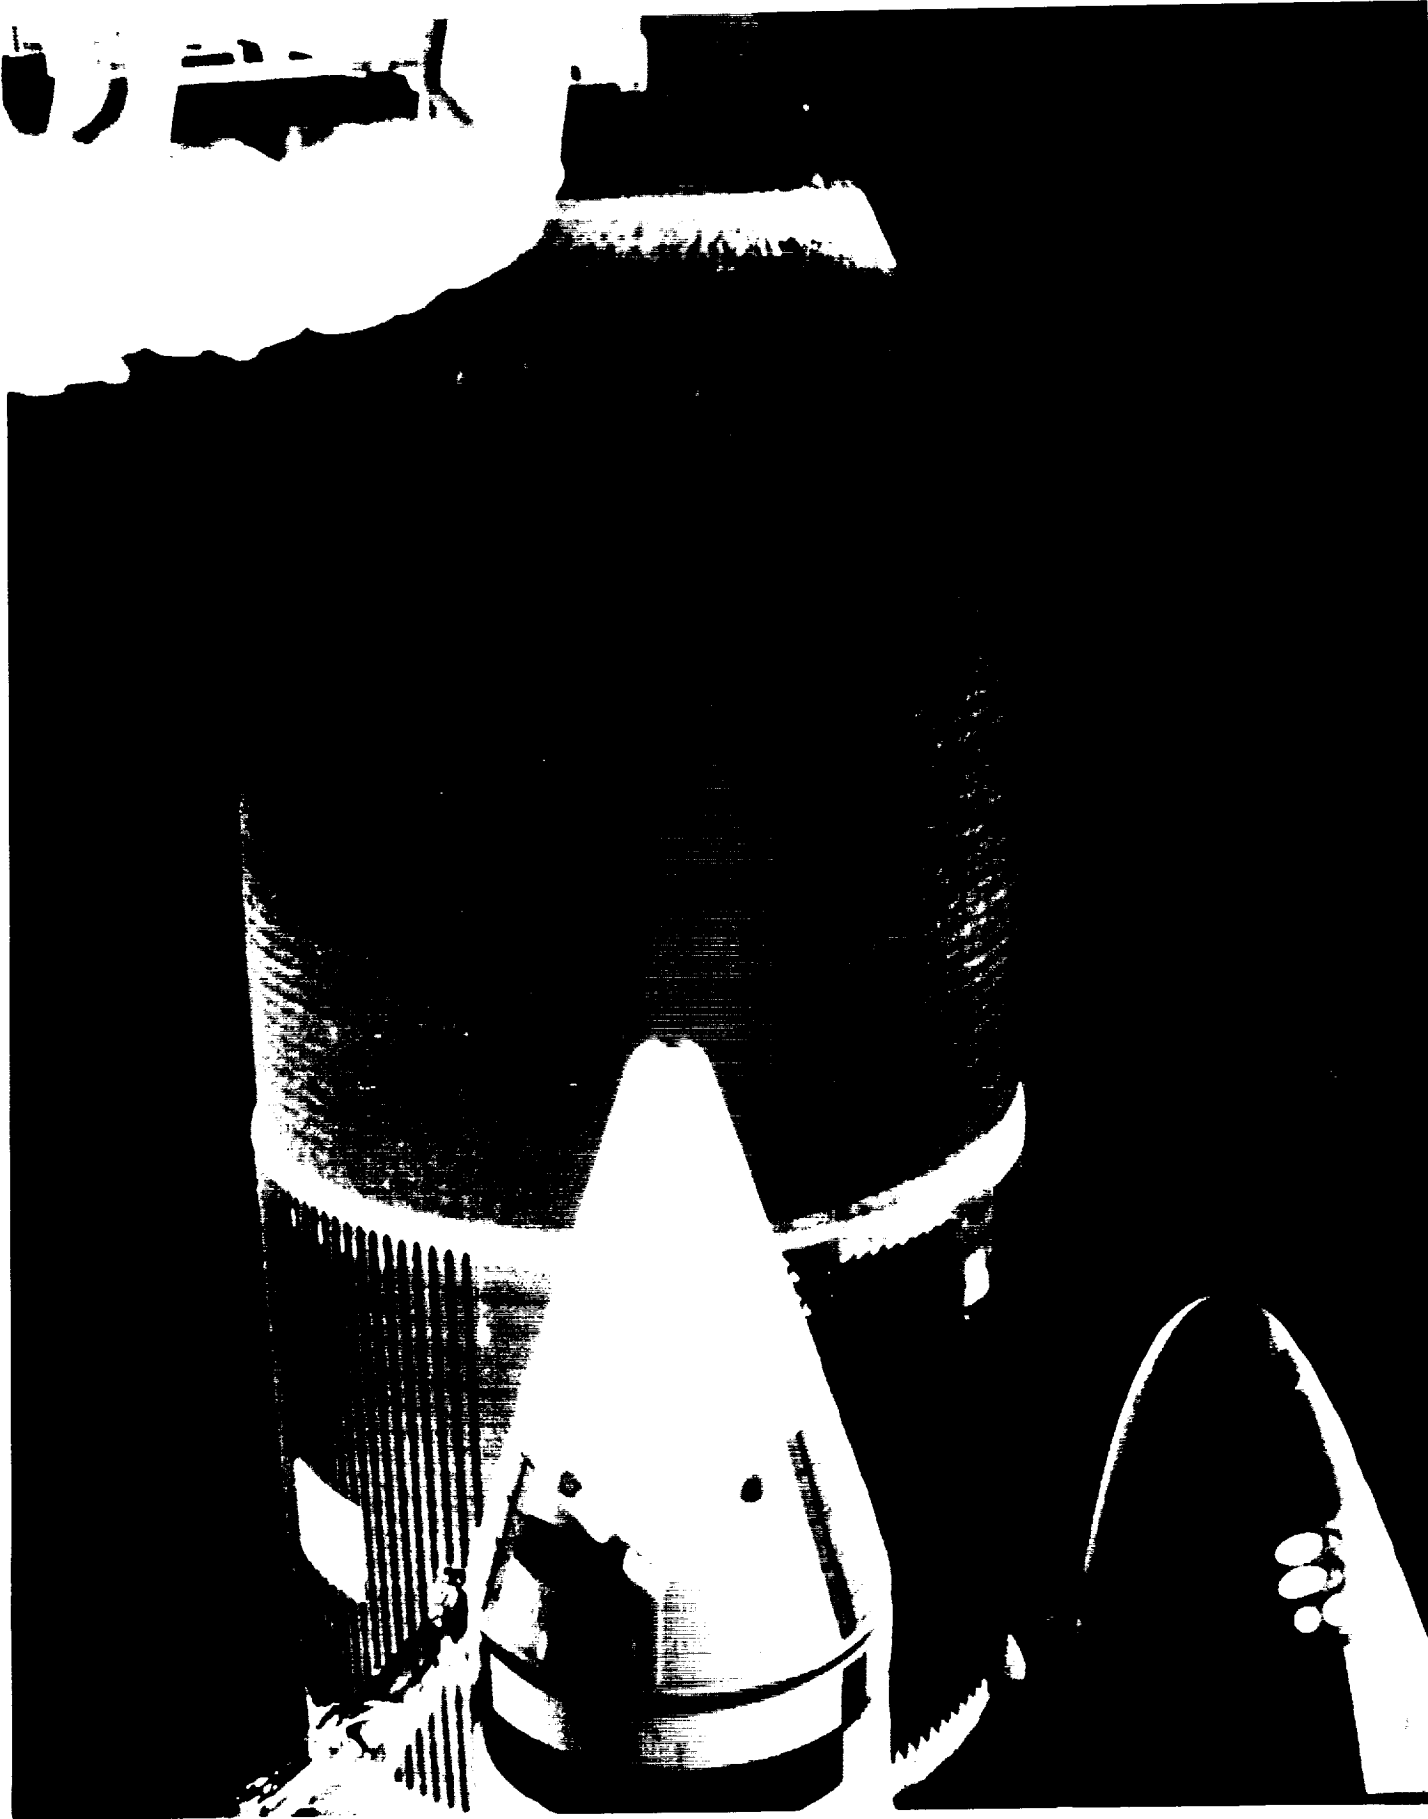
Overall view of ET-46 L02 tank. No ice/frost had formed on the acreage TPS, though the tank was wet with condensate. Note SOFI spray interrupt/sanded area on ogive section.

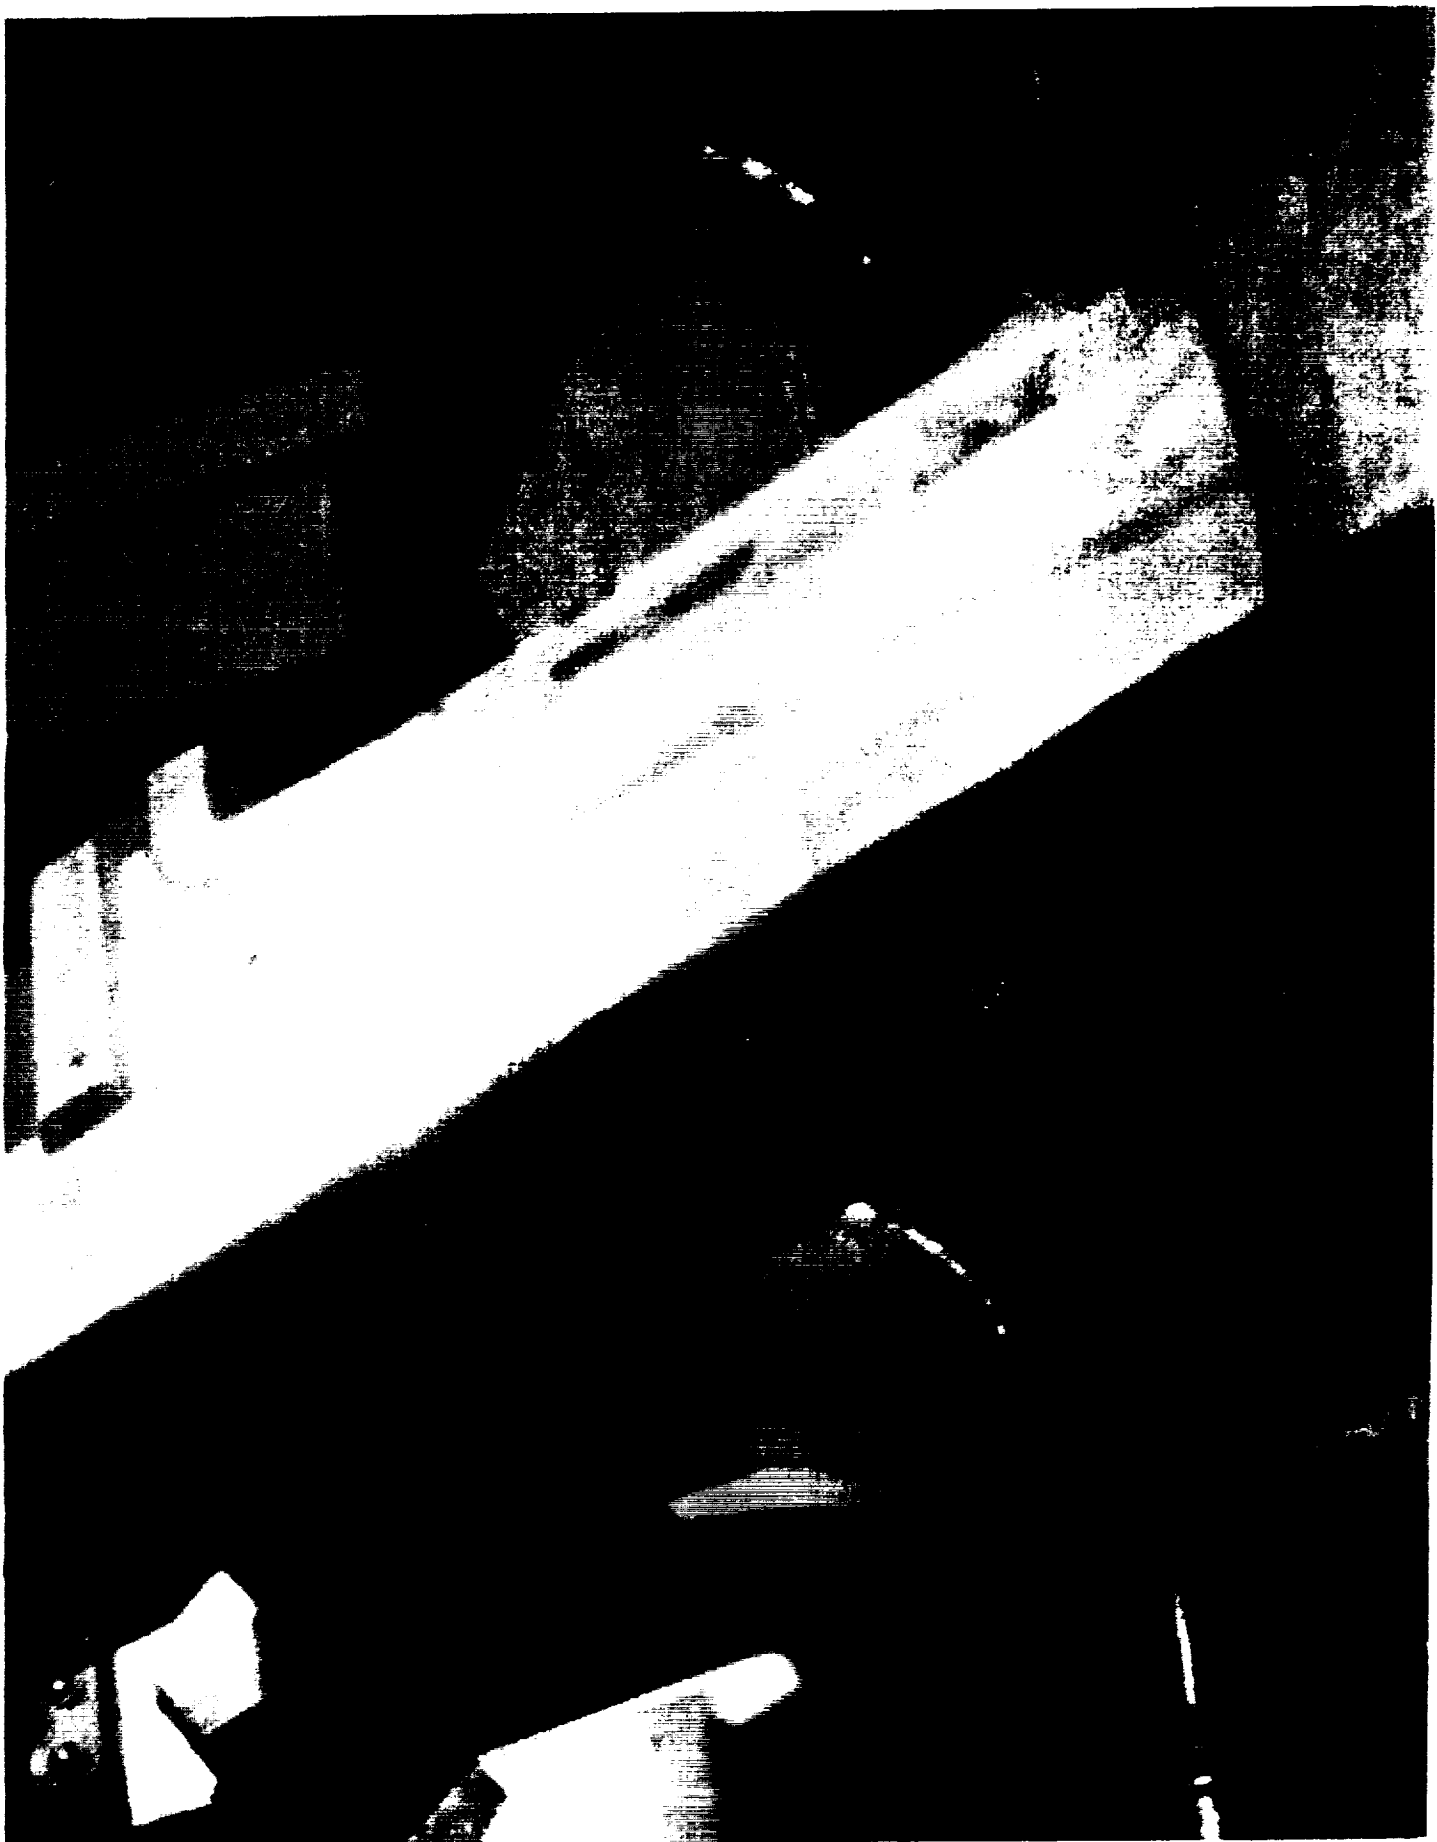
Typical ice/frost accumulation in L02 feedline lower bellows

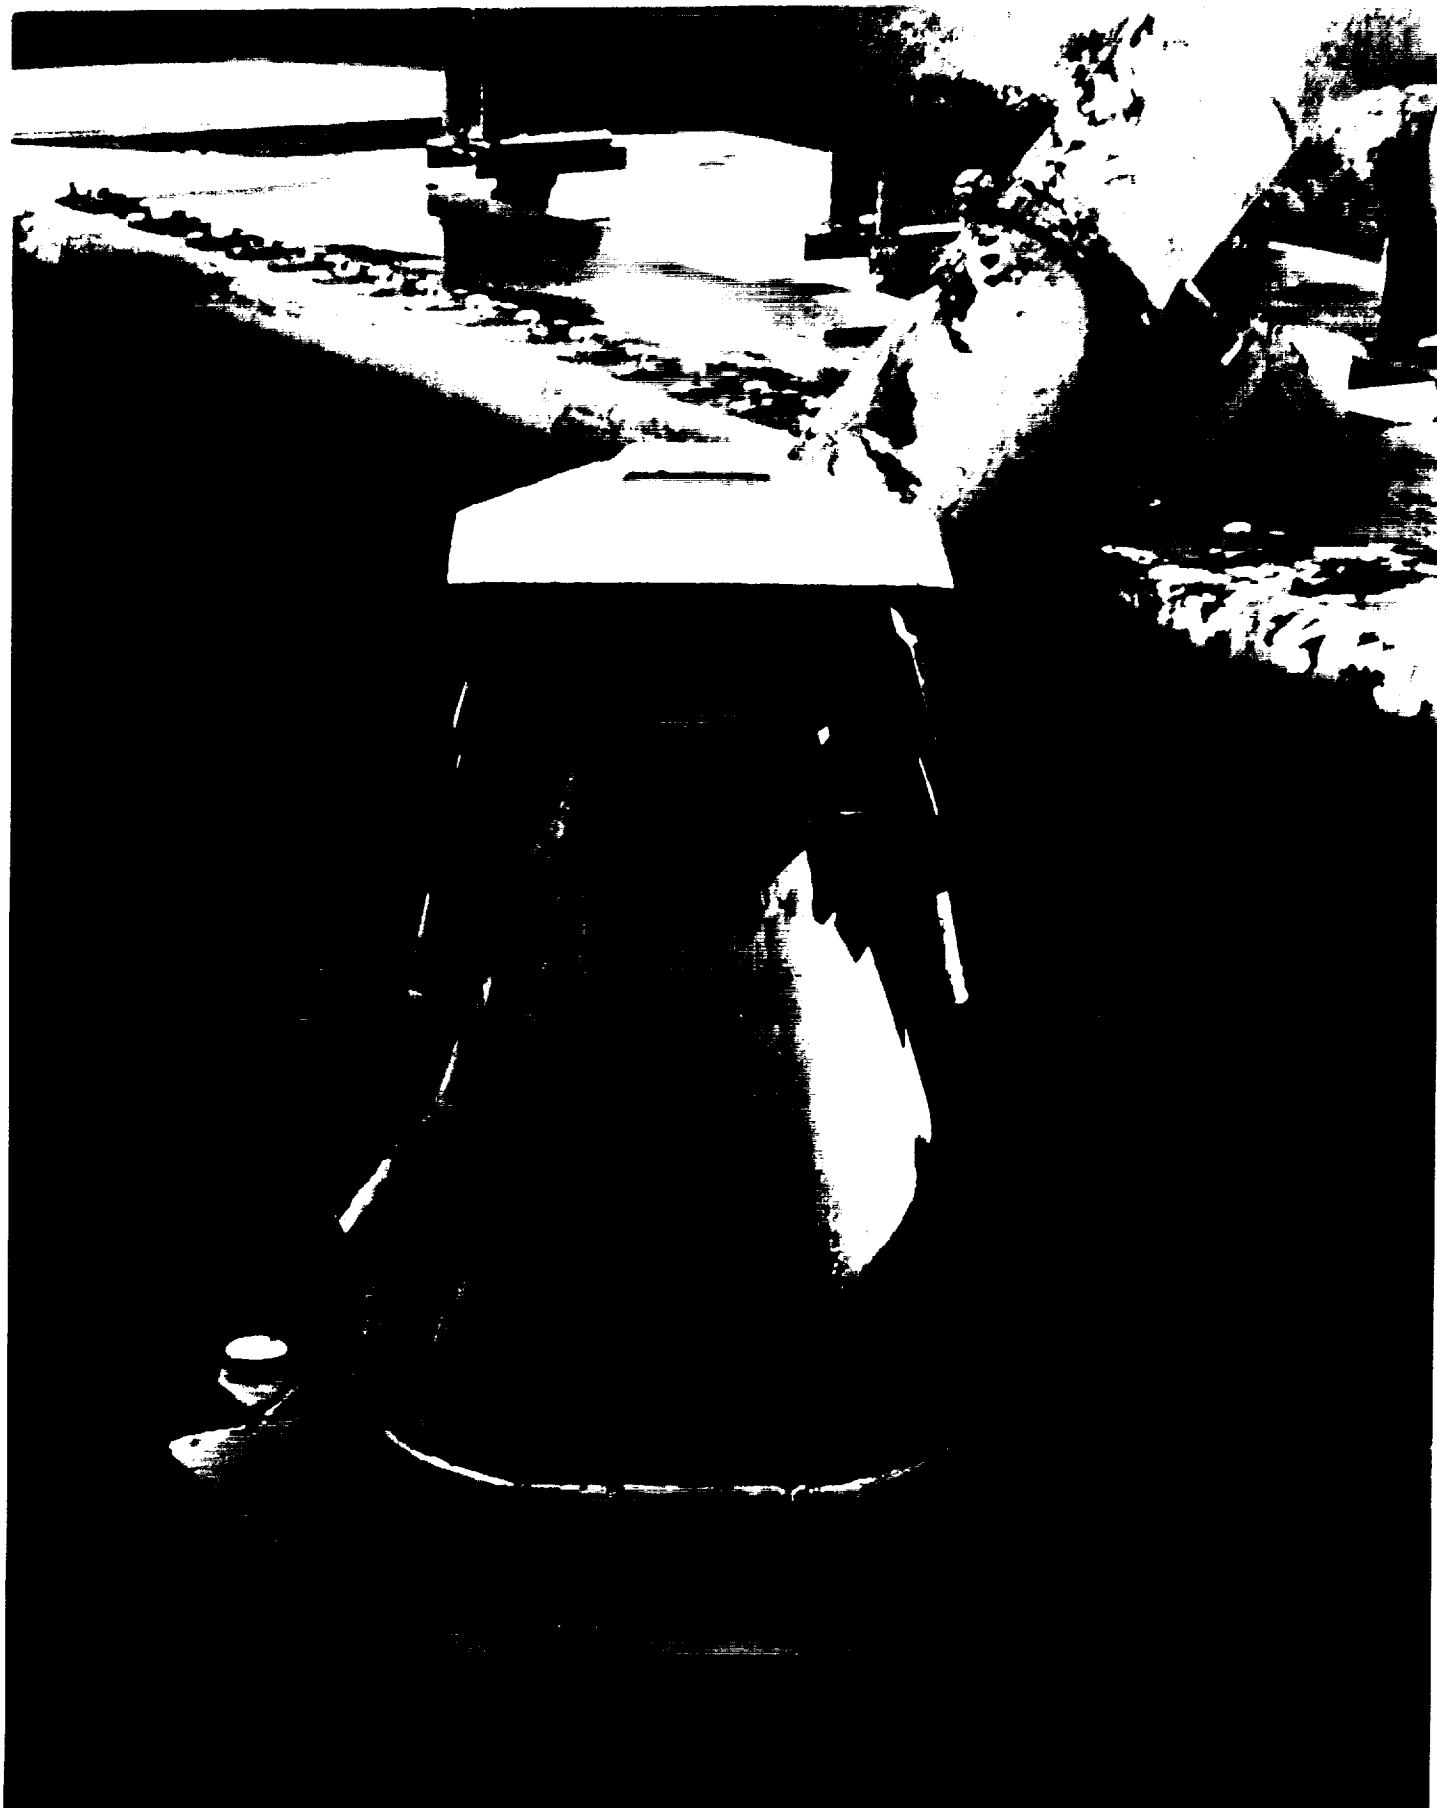
All doghouse blast covers on the north holddown posts had closed properly. Plume erosion appeared to be less than usual.

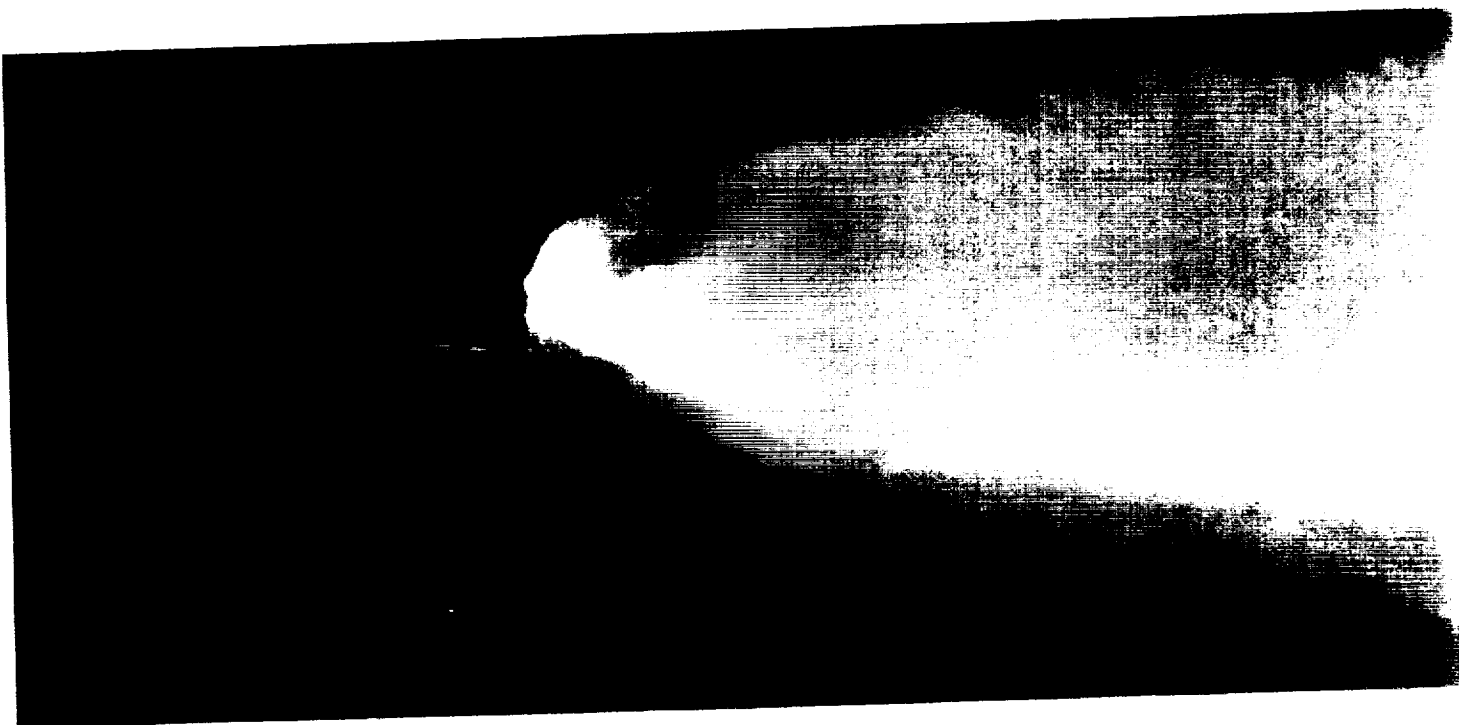
Brightening (more visible flame), along with puffs of darker smoke, occurred in the SRB plume at 111 seconds MET

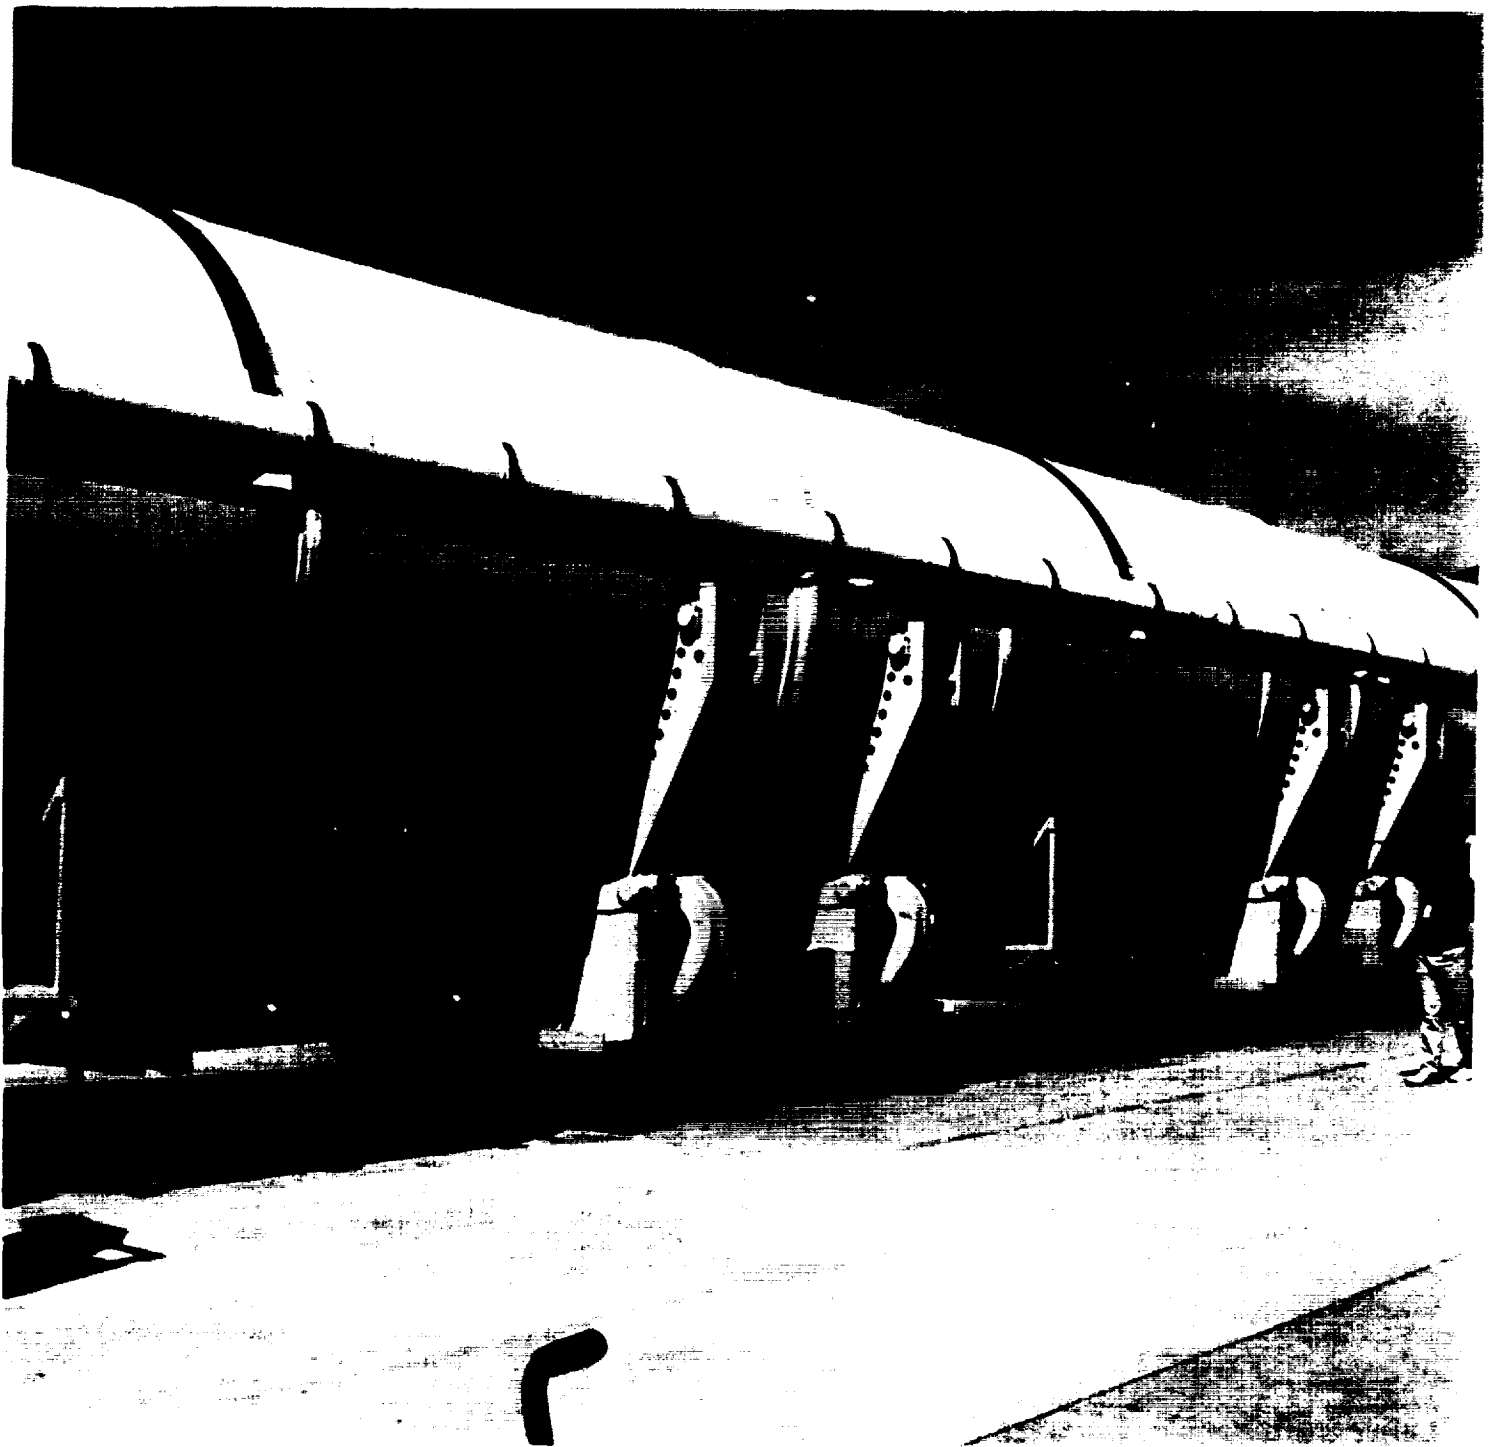
Post flight condition of LH SRM segment cases. The field joint protection system closeouts were generally in good condition.

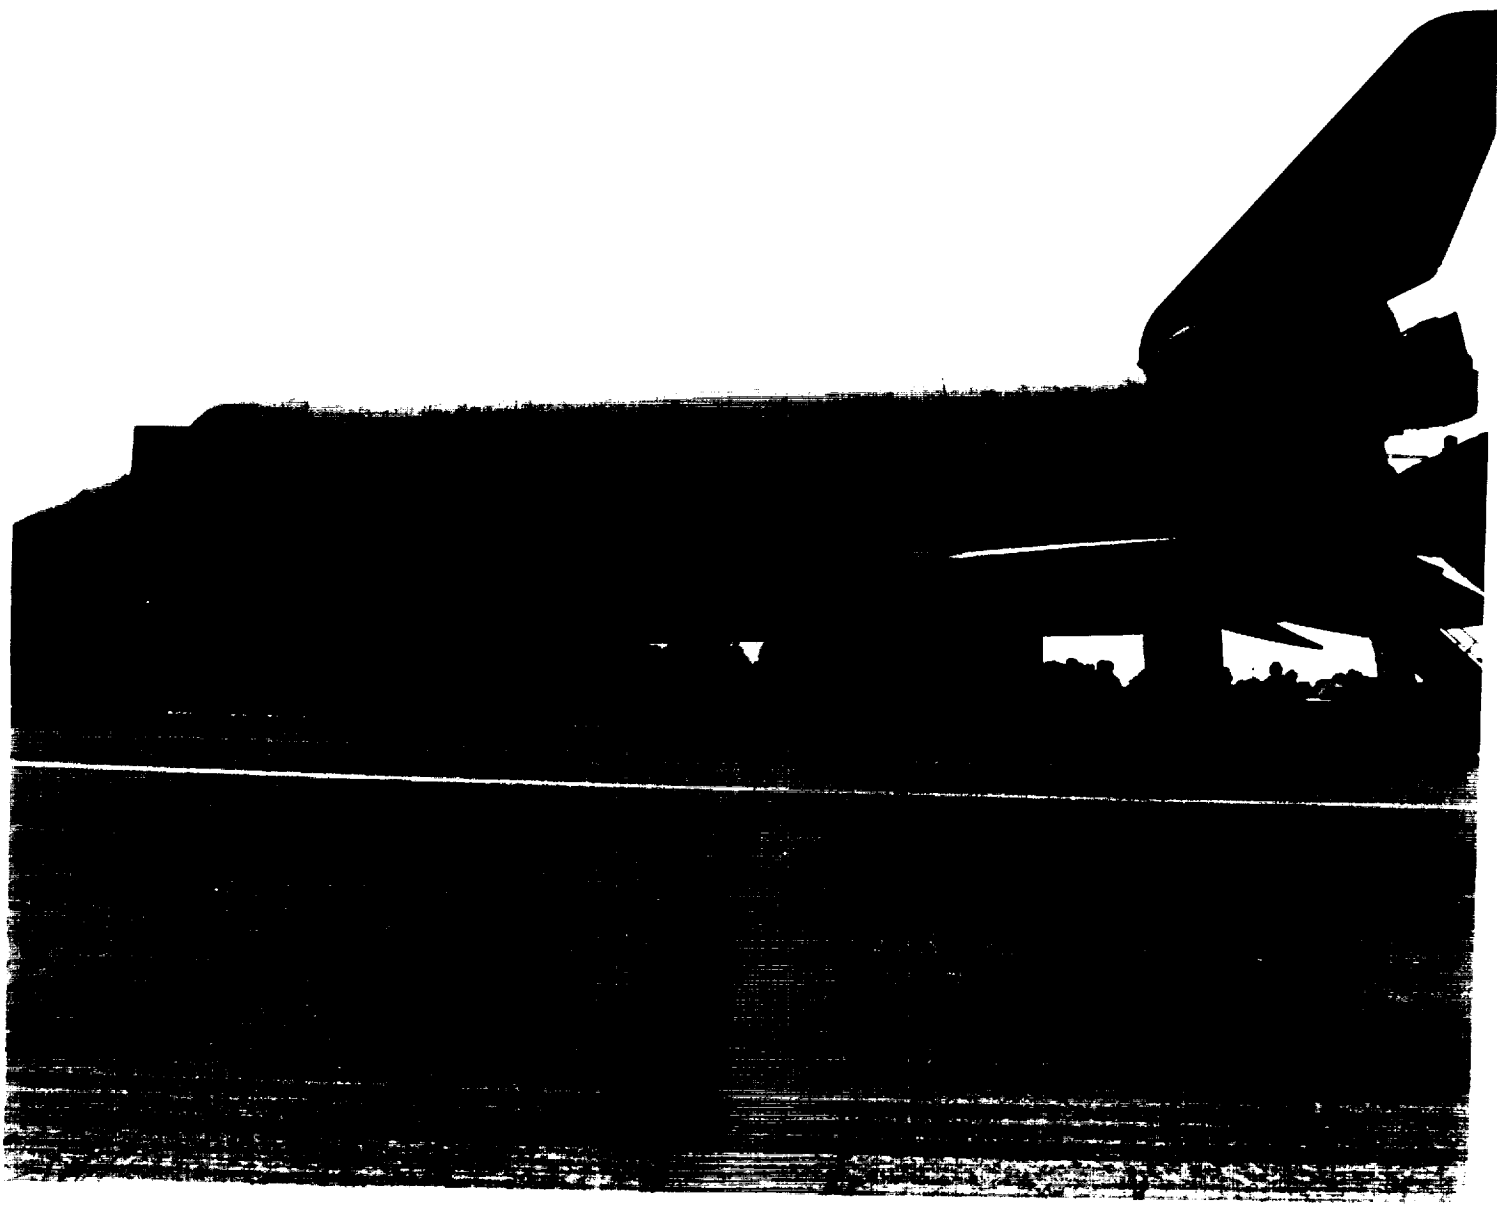
Overall view of OV-103 left side

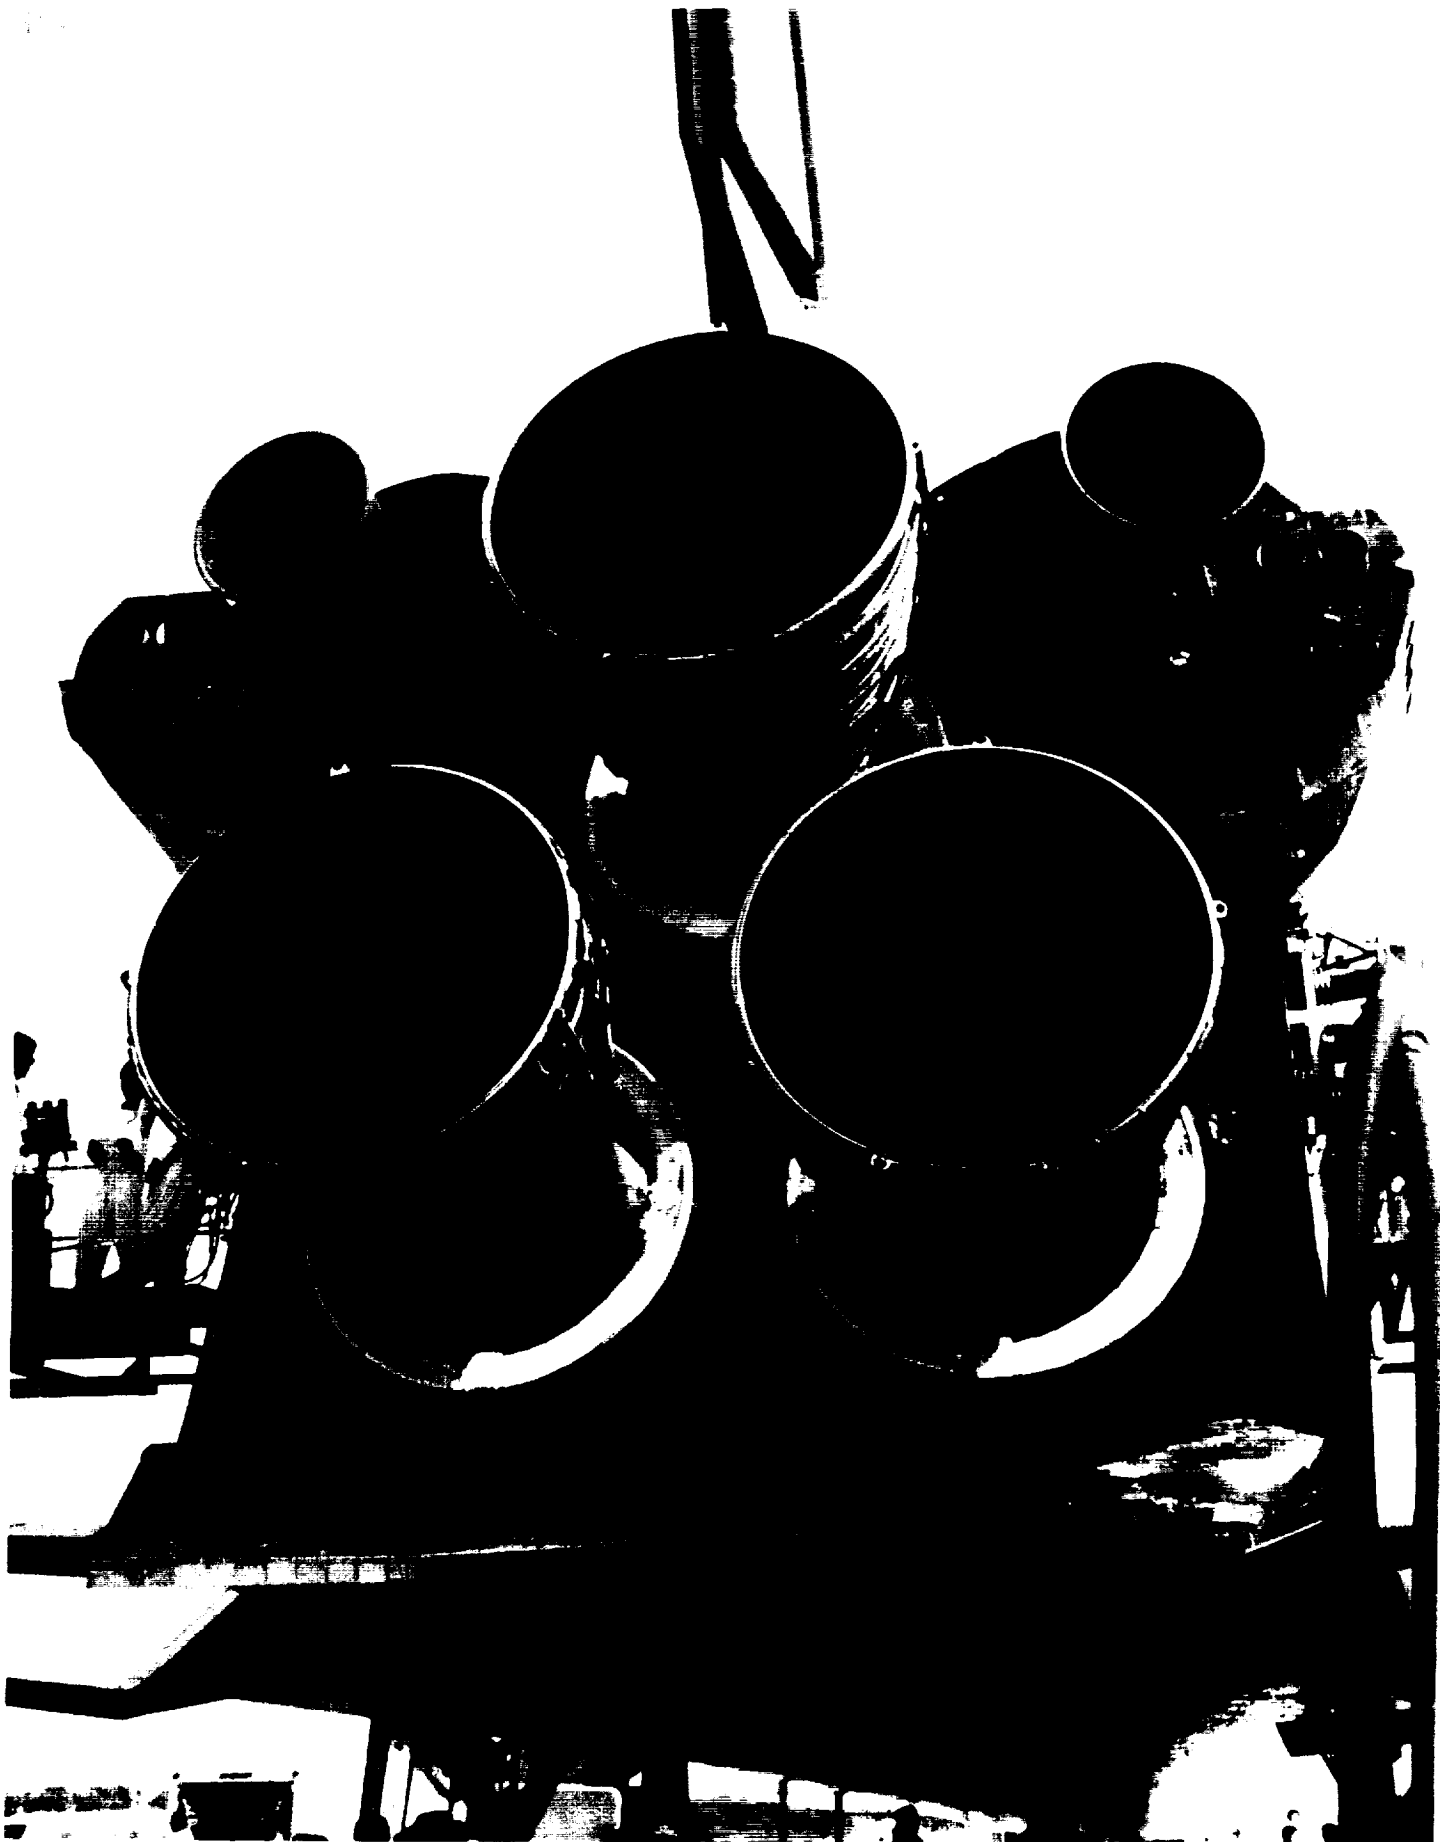
Overall view of SSME's and base heat shield area
